## Trail Improvement

## Oxbow Field Habitat Enhancement

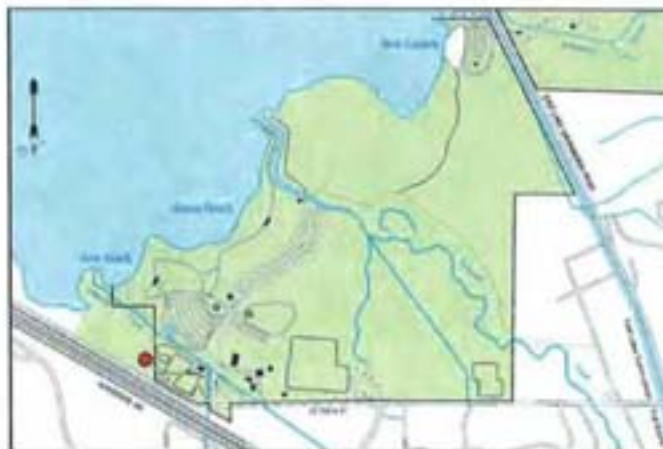
● Project location

Just west of the baseball fields is a trail that meanders through the trees and is used primarily by children riding bikes while their siblings play baseball.

This trail could be improved for greater use by park visitors by providing a destination and a reason for meandering. The fairly aimless form of the existing trail invites non-use. Trail destinations could include an area along a restored portion of Tibbetts Creek, and a connection to a larger trail system in and around the restored Greenwood property as presented in Project C4. Additional plantings along the trail could increase aesthetics and provide enhanced food and cover opportunities for wildlife.

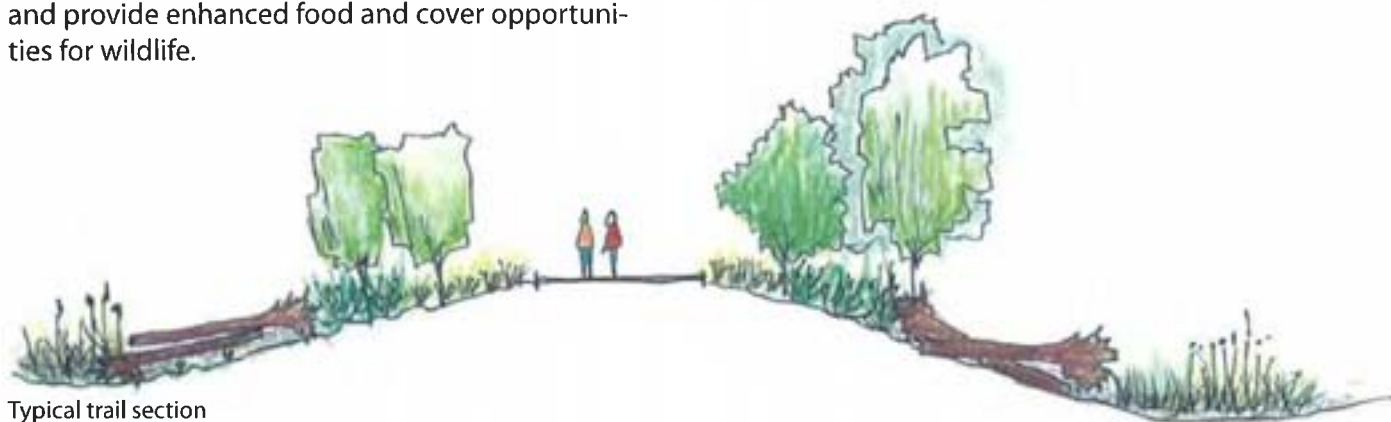
Typical trail section

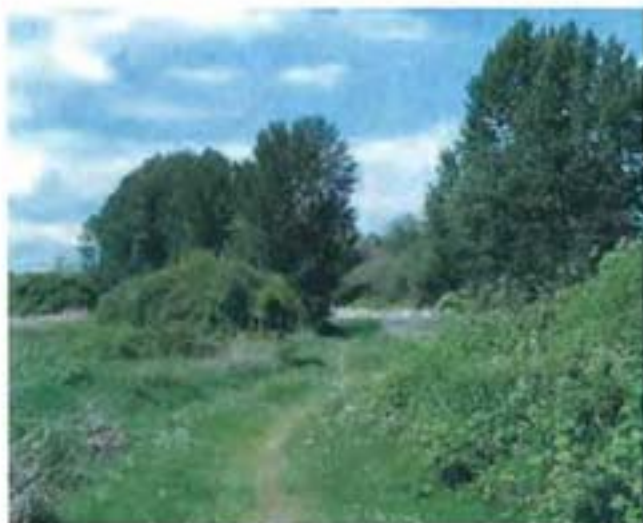
Existing trail near baseball field

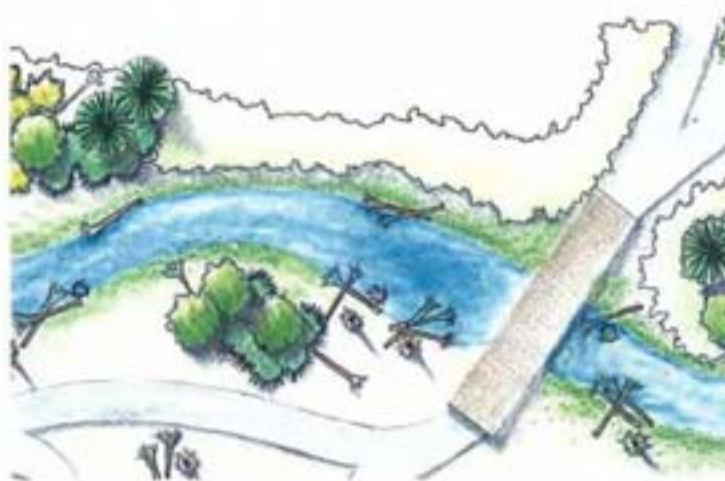
Trail connections over Tibbetts creek

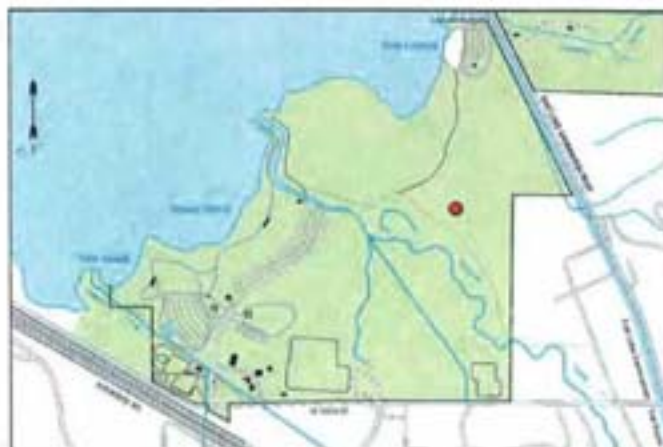
● Project location

The field northeast of the old oxbow on the north side of Issaquah Creek is approximately 20 acres in size. This area is a combination of wetland and upland features, bordered by wetland to the north and east and by Issaquah Creek to the southwest. An existing trail is located in the southern portion of this field. Much of the area is dominated by a variety of grass species, horsetail, buttercup, and vetch, bordered by blackberry thickets and trees beyond. Patches of soft rush, slough sedge, and reed canarygrass are present in the wetter portions to the east. This area was not specifically delineated in the Wetlands Inventory for the Lake Sammamish State Park Property (The Coot Company, 2005), but was generally described and identified in the discussion of Issaquah Creek Uplands. The report characterizes this area as a "combination of slightly higher ground built up from flood overflow deposition plus the drainage effects from the creek channel 'zone of influence' which has created mostly linear 'islands' of upland ground along both sides of the creek."

This area provides an opportunity to create a variety of upland and wetland plant communities, which could be designed to provide a unique

assemblage of food and cover opportunities for wildlife diversity. Forest and shrub patches or islands could be planted in a scattered manner to maximize edges while maintaining the open meadow character of the area. This project could be combined with Project B9, which proposes an interpretive area and trail highlighting the oxbow and associated stream processes.

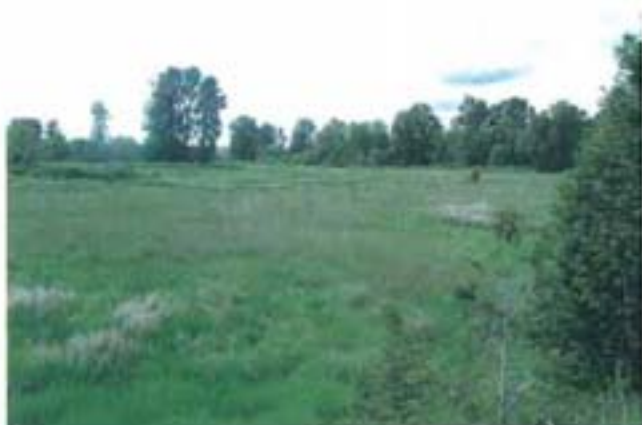
Existing open field lacks habitat values

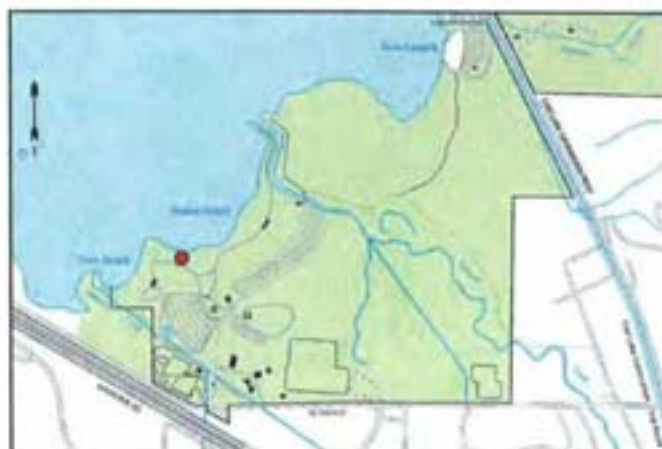
● Project location

The lakeshore wetland between New Beach and Sunset Beach is a fairly diverse community of aquatic, emergent, scrub-shrub, and forested wetland features. However, there are portions that have become dominated by reed canarygrass and blackberries, both in the interior of the wetland and along the edges. This wetland was identified as Wetland 5A in Wetlands Inventory for the Lake Sammamish State Park Property (The Coot Company, 2005).

The lakeshore vegetation fringe could be expanded into reed canarygrass areas by mowing and installing willow stakes in clusters. Western red cedar and Sitka spruce trees could be implanted among the existing trees and shrubs to add a coniferous component to this habitat. Additional shrub plantings such as gooseberry, twinberry, salmonberry, and rose could be planted in clusters to increase edge habitat and wildlife food and cover values. Logs and woody debris could be installed to increase the structural diversity of the habitat. Native emergents such as hardstem bulrush could be installed along the lakeshore. Wetland buffer vegetation should be planted where possible, as described in Project A7. This

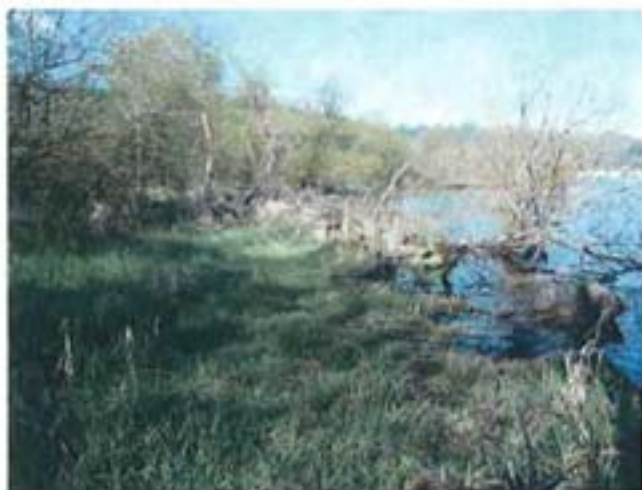
Lakeshore between New Beach and Sunset Beach

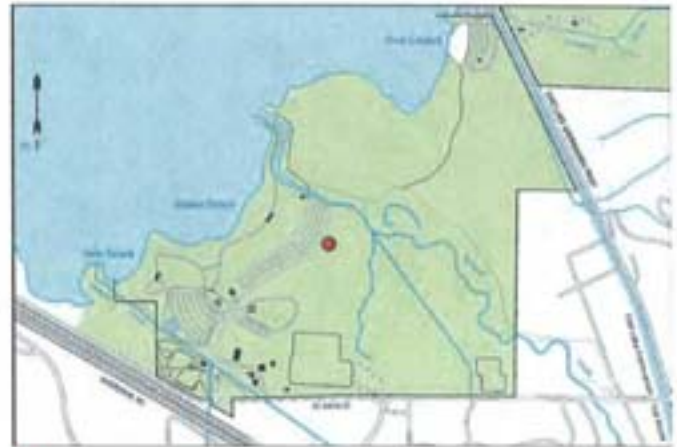
● Project location

This wetland is approximately 5.7 acres in size, located to the southeast of the Sunset Beach parking lot. Bat boxes on poles were installed here as a Boy Scout project several years ago. The wetland is comprised of mostly reed canarygrass with blackberry edges and some patches of soft rush. There are willows and cottonwoods beyond the field margins. Several ditches direct water from and through this area to a ditch paralleling the Sunset Beach parking lot.

The natural habitat values of this wetland could be increased by mowing the reed canarygrass and installing dense patches of native trees and shrubs. Plant species should be chosen for their wildlife food and cover characteristics. It is also recommended that several of the existing bat boxes be moved from the installed poles to adjacent tree trunks to possibly increase their use by bats. Bat slabs could also be installed on some of the trees to investigate their relative use compared to the boxes. These habitat features should be oriented to the south or west to maximize their warmth and potential use by bats. An interpretive sign explaining the habitat structures is a good educational opportunity, especially since this is

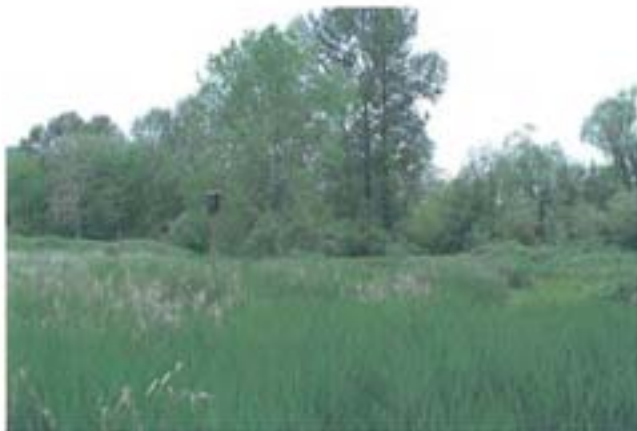
This site has potential for wildlife habitat enhancement

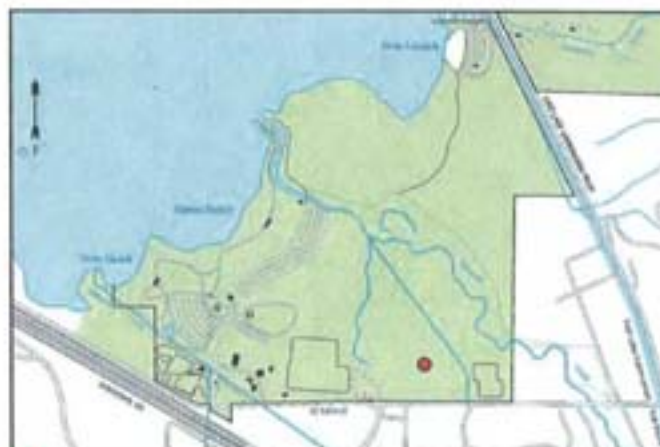
● Project location

The area between the two sets of soccer fields is a combination of wetland and upland features, approximately 23 acres in size. A ditch near the eastern "Costco fields" directs water northward into Issaquah Creek. Much of the area is open grassy field dominated by a variety of grass species, thistle, vetch, and horsetail. Blackberries are dense along the edges of the field with some willow, rose, cottonwood, ash, and hawthorn thickets. This wetland area was delineated and identified as part of Wetlands 6A and 6B in Wetlands Inventory for the Lake Sammamish State Park Property (The Coot Company, 2005). The report also indicates that the ditch near the eastern soccer fields receives significant input from storm-water runoff from the City of Issaquah.

This area could be restored and enhanced with removal of blackberries and revegetation at least on the edges of the existing field. Scattered islands of native trees and shrubs planned to correspond to wetland and upland conditions would provide additional food and cover values for wildlife habitat. As the area is near an existing trail, an interpretive sign could be installed to explain habitat enhancement and the value of additional

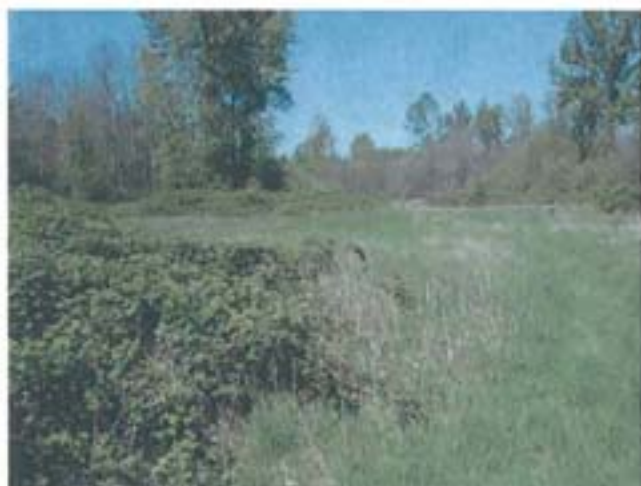
Himalayan blackberry dominates edge of the wetland

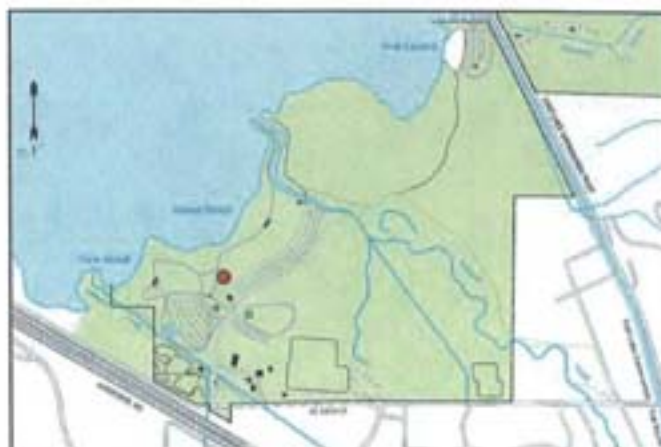
● Project location

This mostly upland forest area is approximately 2.8 acres northeast of the New Beach parking lot. The existing plant community is dominated by black cottonwood, red alder, Oregon ash, snowberry, osoberry, red-osier dogwood, and salmonberry. Blackberries, both Himalayan and evergreen, have taken hold with reed canarygrass along the edges of the forest.

The fairly diverse forest community could benefit from removal of invasive plants, particularly blackberry and reed canarygrass. Follow up with additional plantings of shrub species to combat invasive weeds and improve habitat values would improve project success. Plantings could include more of the existing shrub species, additional upland shrub species chosen for their food and cover values, and conifers to increase the habitat diversity of the overall area.

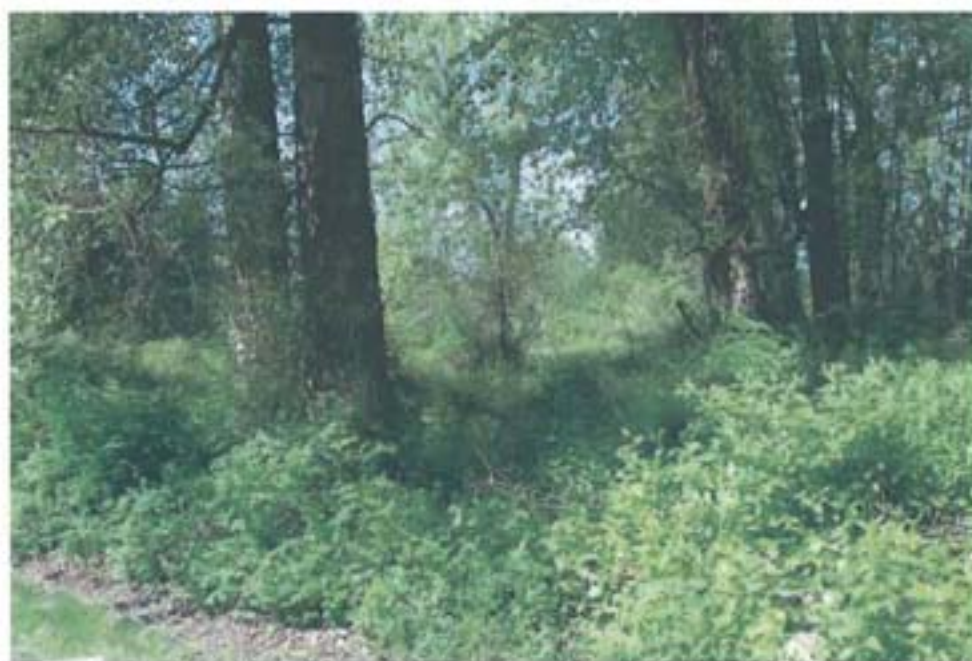
Edge of the upland forest

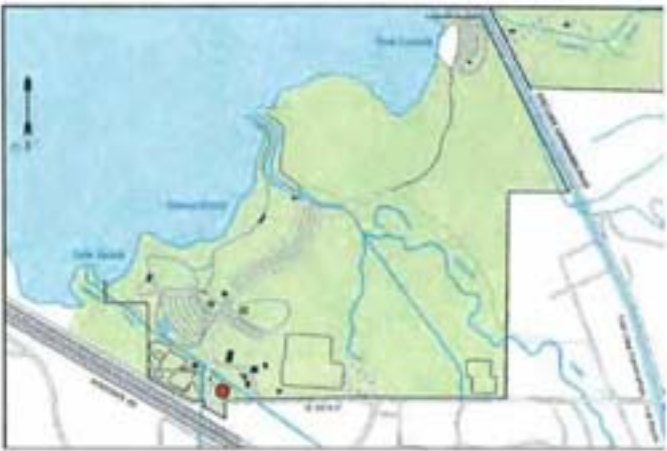
● Project location

East of the park entry road and south of Tibbetts tributary #0170, the existing wetland/forested community is dominated by black cottonwood, red alder, and Oregon ash in the canopy. The understory is comprised of willow, red-osier dogwood, rose, twinberry, snowberry, osoberry, and blackberries. Blackberry thickets, both Himalayan and evergreen, are dominant along the edges with reed canarygrass. The wetland was identified as Wetland 8 in Wetlands Inventory for the Lake Sammamish State Park Property (The Coot Company, 2005).

This fairly diverse community could benefit from removal of invasive plants, particularly blackberry, English ivy, and reed canarygrass. Follow up with additional plantings of the existing shrub species to combat invasive weeds and improve habitat values would improve project success. Wetland buffer plantings could be established along the west side of the wetland which is presently mowed grass. A diverse community of upland shrubs and trees, including conifers would add to the habitat value of this area.

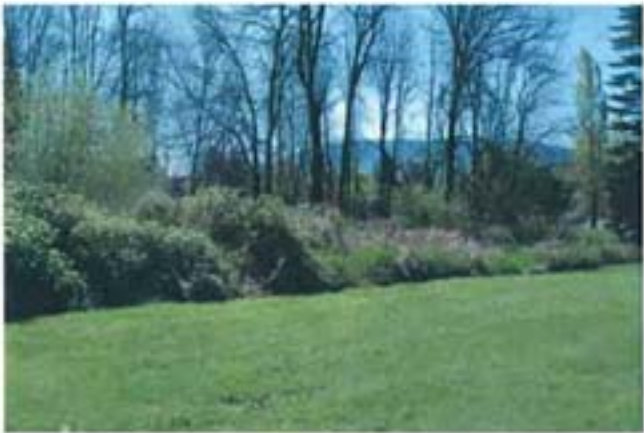
Invasive plants and lawn in the wetland buffer

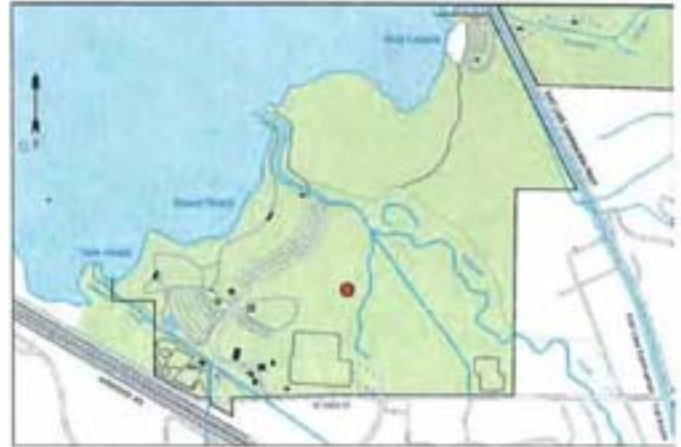
● Project location

A field northeast of the main (western) soccer complex is approximately seven acres in size. There is a ditch along the southwest side between the maintained soccer area and this field. This area is presently dominated by reed canarygrass, fairly large patches of slough sedge, and horsetail with scattered Oregon ash trees. Blackberry thickets are present throughout and particularly along the edges of the field. Edge habitat between the different plant types is well-distributed. This area was not specifically delineated in Wetlands Inventory for the Lake Sammamish State Park Property (The Coot Company, 2005), but was identified as part of Wetland 6.

Removal and/or control of blackberry and reed canarygrass would be beneficial to the habitat value of this area. Follow-up revegetation should include plant species chosen for their food and cover values for wildlife. The habitat values of existing tree and shrub thickets could be expanded and improved with additional species diversity. This project could be combined with Project A9 for enhanced educational and passive recreational opportunities.

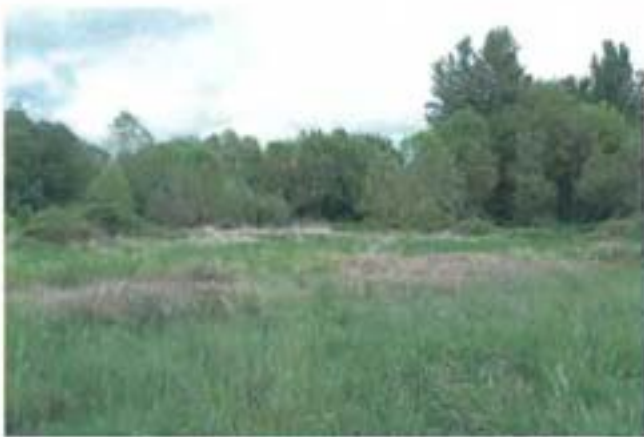
Existing open field is dominated by invasives

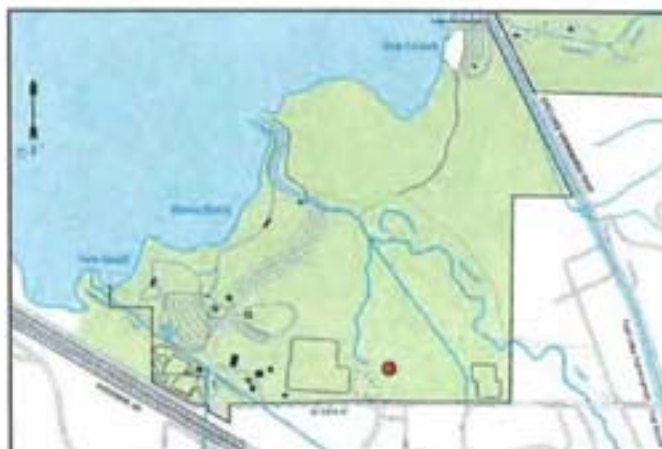
● Project location

There is an informal park compost area north of NW Sammamish Road between the two sets of soccer fields. This area could be organized into a more efficient composting operation that would provide materials to be used throughout the park and for restoration projects. Revegetation along the edges could help to define and screen the composting area, as well as prevent encroachment into the surrounding natural communities.

This operation could also serve as a “how to” interpretive area to explain composting. Various stages of decomposition could be shown resulting in potting soil quality, vermicompost (worm bins), and information about not attracting pests, such as rats and other rodents.

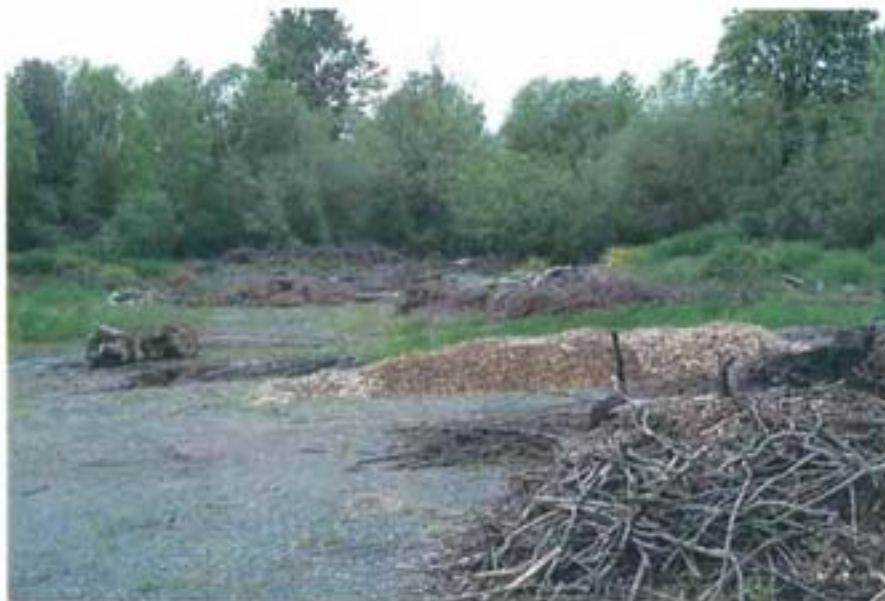
The informal composting area
